## Repair report for Army Hut.

*Before and after, Army Hut, Snowdon Conservation Area*

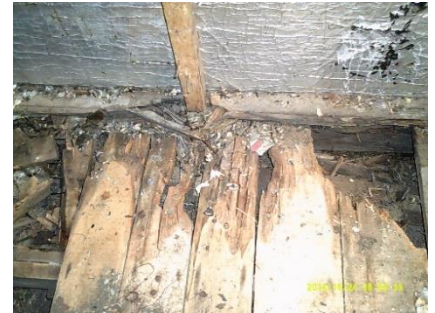
*Rotting floor boards*

Thanks to the kindness of Takaro Lodge we staged at the Lodge and flew to Army hut. We got all the gear unloaded and set up camp. That first evening after tea we gutted the hut taking out all the bunks, benches cupboard and shelves, nearly all riddled with wood borer. There were a few scraps of carpet and lino that we tossed also and that revealed the true state of the floor.

The next day we removed the floor which revealed the state of the hut sub structure. The hut was resting on rotted beech logs which we replaced with piles and treated 100X100 beams, we also cut the rotten parts out of the joists and replaced them with treated 100X50 joists and the whole hut jacked up back to level.

All existing timber in the hut was sprayed with a borer treatment before covering. The new floor was then laid with 19mm treated plywood. We then replaced the sky light and laid a sheet of clear PVC under it to mitigate and condensation.

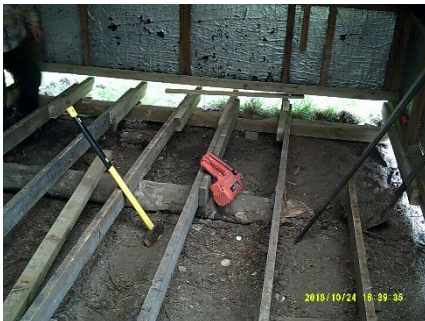
*Beech log bearers*

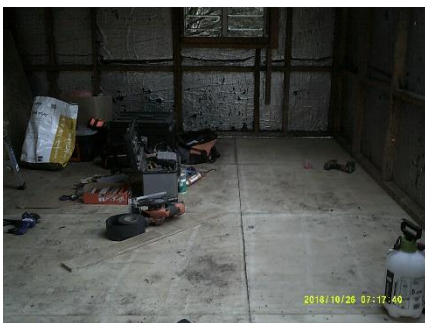
*New floor laid*

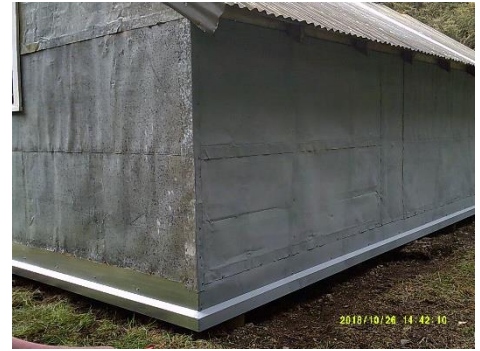
*Flashing in place.*

A flashing was then inserted up under the wall tin that came down past the top of the piles. The walls were painted with cold galv and the roof painted green.

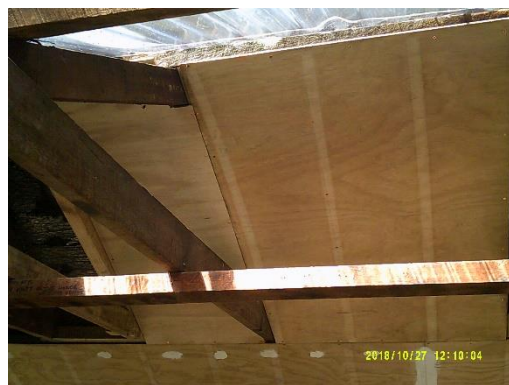
*Ceiling round the sky light*

We then set about lining the walls and ceiling with 7 mm treated plywood which when up was painted white. We clad around the sky light to give it full benefit.

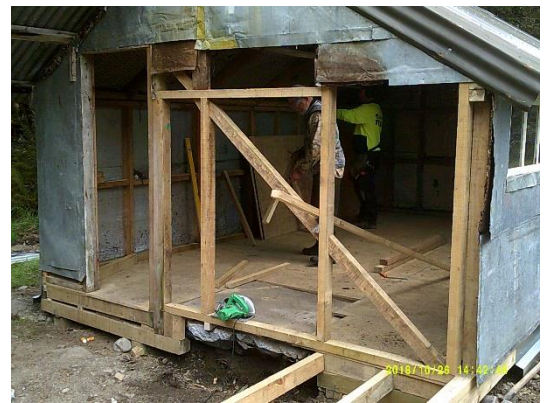
was only a two skinned unit), the new, (second hand) fire box was installed with the *End wall framed and braced* correct three skins and framed up to the new ceiling.

The old chimney was removed with the intention of replacing it but a combination of its very poor condition and lack of spare timber meant it was not replaced, it basically fell apart when we pulled it down, we removed about 2 cubic meters of rocks and ash from the fire place and then framed and clad the end wall.

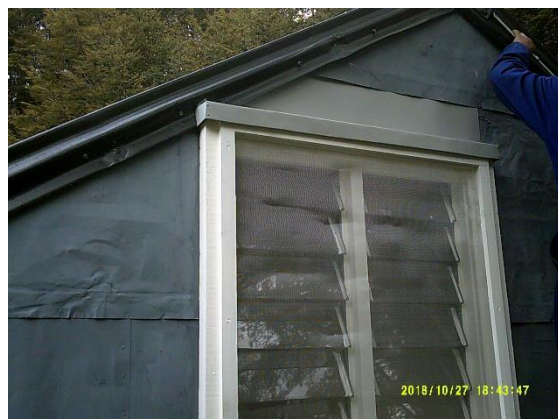
*Window meshed and flashed*

The back window was painted, framed, and meshed and then flashed. The louvers now open fully and the hut is now fully sandfly proof.

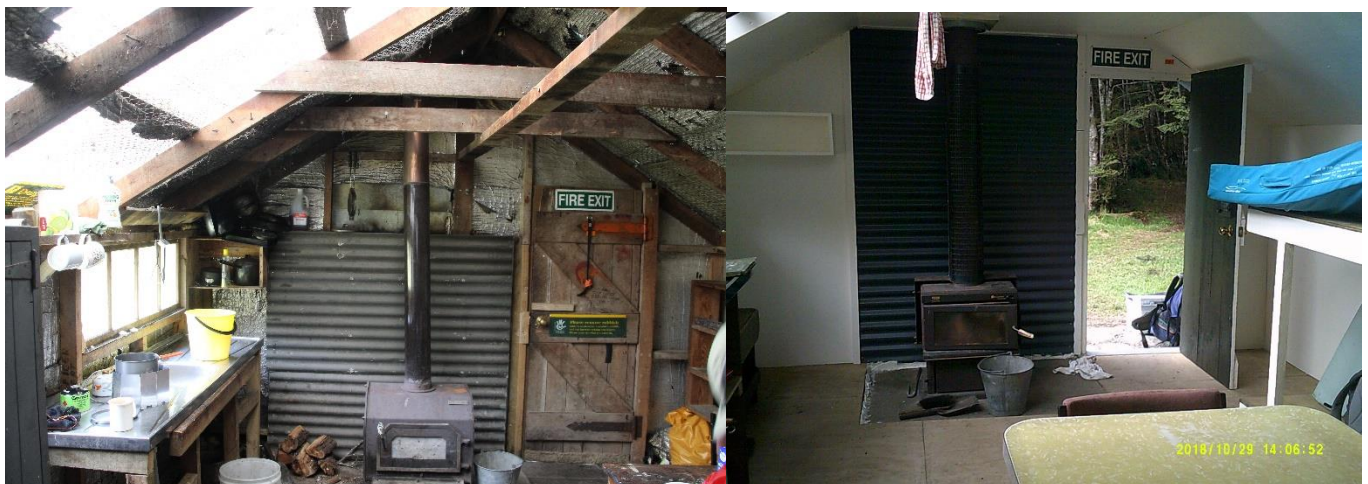
*Before and after of the fireplace end of the hut*

The old fire box was removed along with the flue and cap, ( it
