Report: Tautuku Hut renovation.

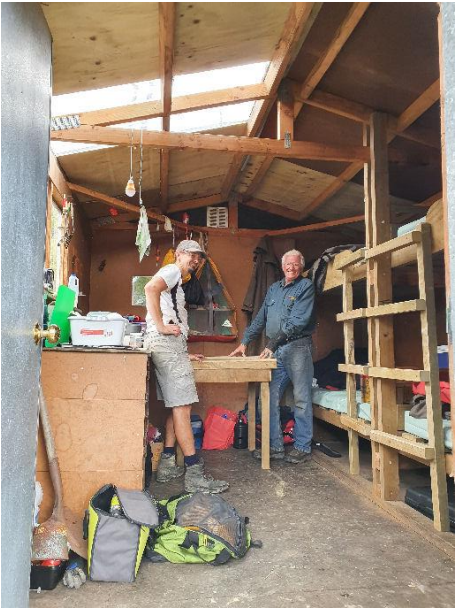
The tin on the walls of the hut did not come down over the join of the floor bearers with the with the piles so we took the screws out of the bottom of the tin and slipped up under the tin a skirt so that rain is directed down over the top of the piles. The roof had just a 50 mm overhang above the walls so we made up some flashings and flashed the roof out to 300 mm out from the walls. We then placed a tin flashing on the door sill.

We painted any rust on the walls with cold galv paint after wire brushing. We then trenched around the hut to facilitate the extraction of roof water from round the hut.
